## Geological Assessment of A Slide Zone on SH-36, Near Kalimath in Rudraprayag District, Uttarakhand, India

A landslide zone stretching nearly 400 m along the SH-36 with the length of 115 m is located nearly 8 km from Guptkashi on way to Kalimath Village in Rudraprayag District, Uttarakhand. The rocks in the slide zone vicinity belongs to Kalimath Formation of Jutogh Group that falls under the Higher Himalaya. The rocks in the slide area are characterized by intercalated sequence of quartzite, schist and gneiss with thin bands of amphibolite. Regional strike of these rocks is E-W dipping due north. The rocks are fragile due to excess seepage of water at places. There are three sets of prominent joints with some variation and random joints. The kinematic analysis indicates possibilities of toppling of the rock blocks particularly with intersection of the joint planes N010°/75° and N110°/60°, where slope is trending N250°/65°. Similarly, toppling has also been indicated by the joint plane N015°/75°, where slope is trending N165°/55°. The 'Sum of Moments' comes out to be 113.57 kN/m, and 107.2 kN/m, respectively, for these two slope conditions, which indicates unsafe slope condition

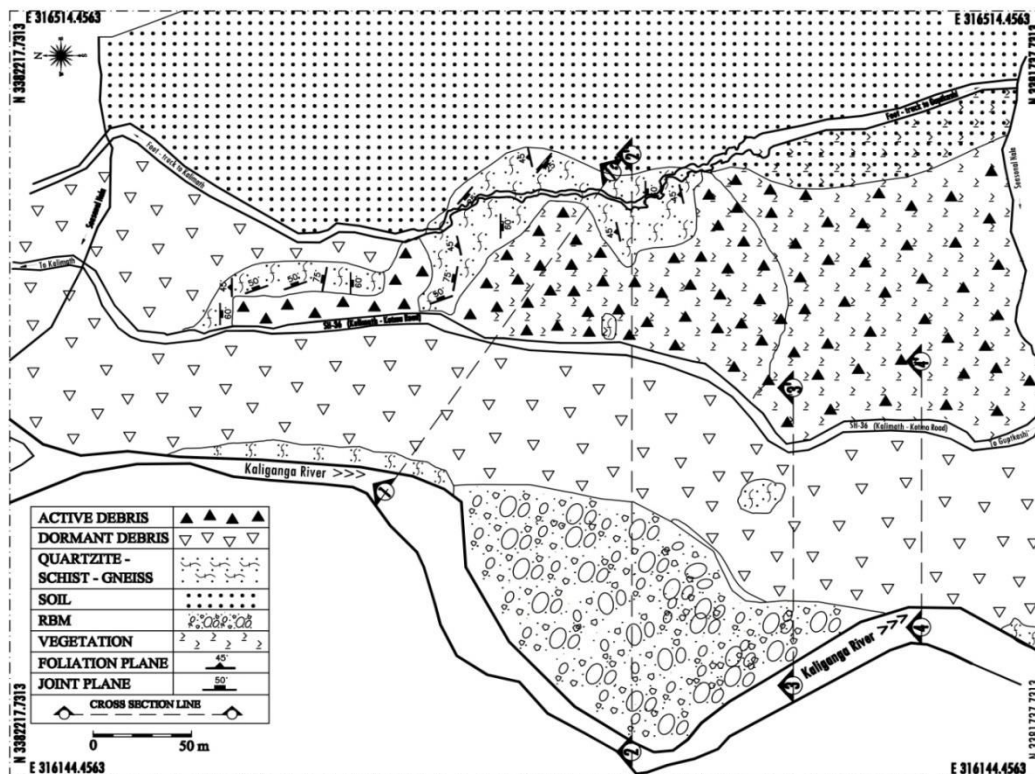
**Figure.1** Geological Map of the Slide Zone

The geological map of the slide zone has been given in Fig 1.

The Km 8 Slide Zone is a stretch of nearly 400 m along the road (SH-36) and is restricted between the two prominent drains on either side. The length of the slide is 115 m. Majority of the area is covered with dense vegetation and soil cover. Toe is often affected by the river, particularly in the monsoon.

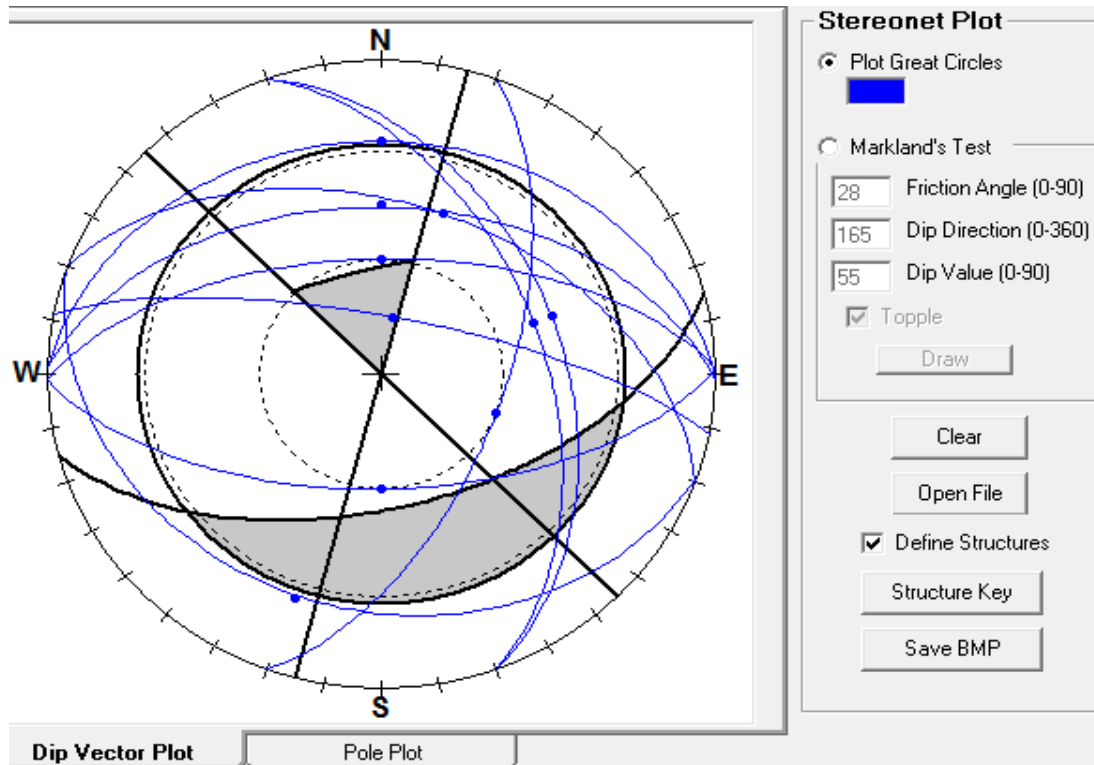
Figure.6 Joint planes plotted on stereo net

The joint planes as mentioned above in Table 1, have been plotted on the stereo net and are shown in Fig 6.

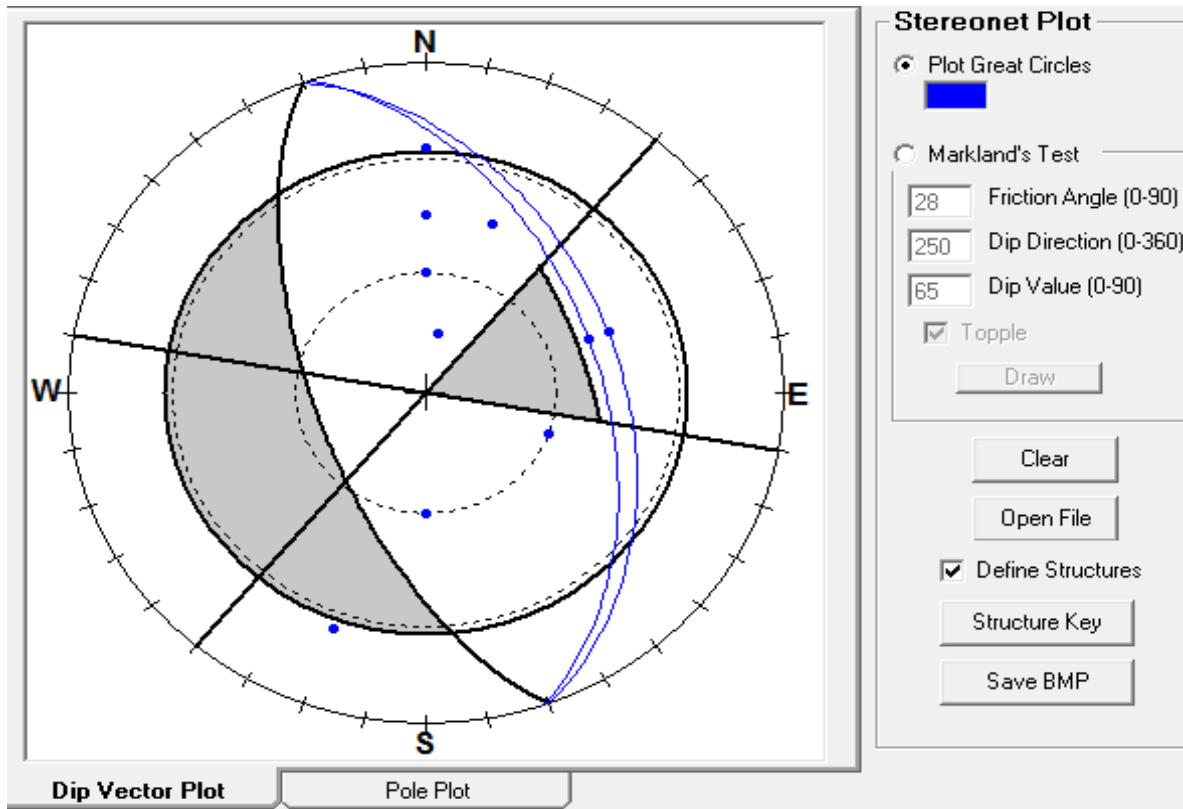
Figure.7 Topple Failure for joint planes trending N070°/50° and N070°/45°

- i) The joint planes N070°/50° and N070°/45°, which appeared vulnerable to toppling in N070° direction, fall just outside the critical zone for Topple Failure (Fig 7; the shaded triangle). Hence, toppling may be ruled out due to these two joint sets.

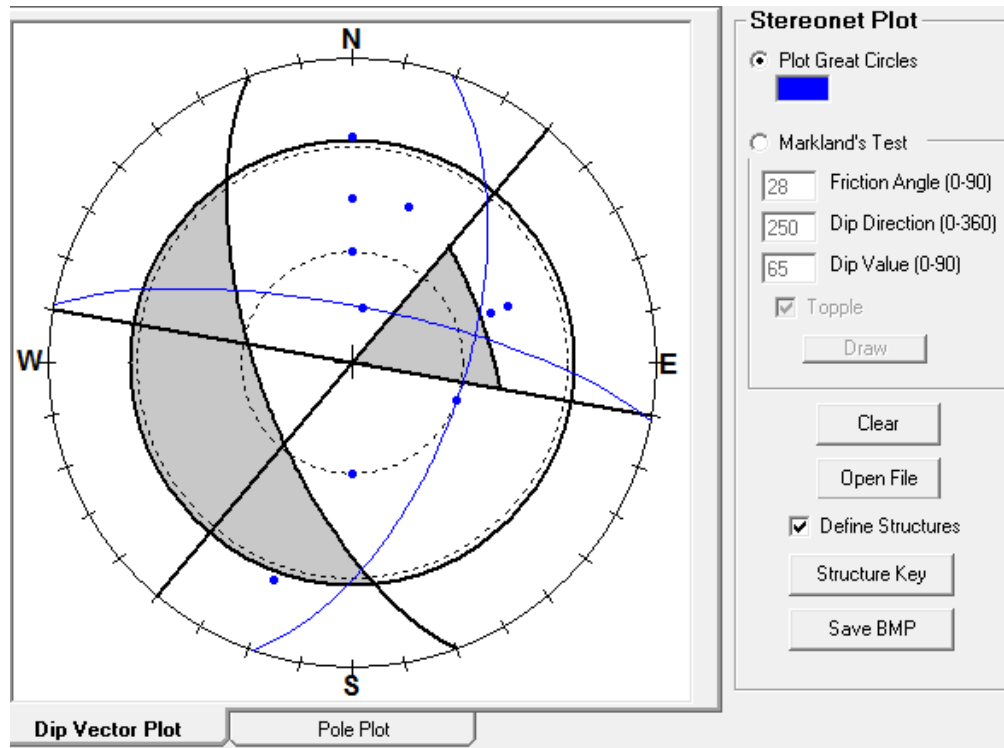
Figure.8a Topple Failure for joint planes trending N010°/75° and N110°/60°

- ii) Intersection of joint planes N010°/75° and N110°/60° fall within the critical area for Topple failure (Fig 8a). It tends N081°/56°, indicating likelihood of toppling towards N081°.

The input parameters for analysis of "Sum of Moments" in case of Topple Failure is shown in Fig 8b, where the value of "Sum of Moments" comes out to be 113.57 kN/m, which indicates unsafe slope conditions.

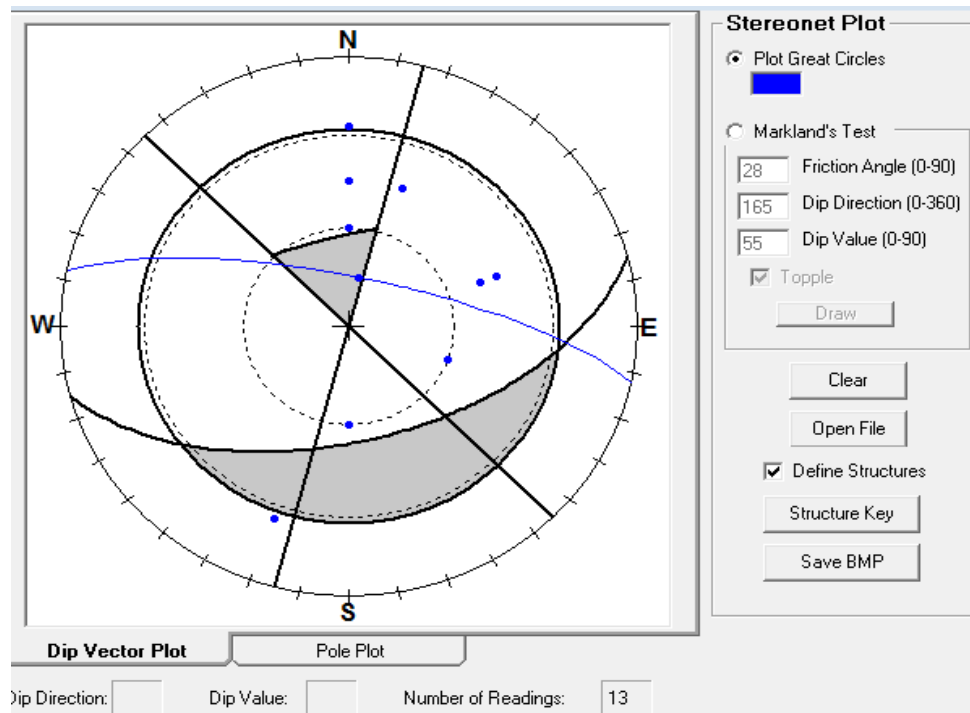
Figure.9a Topple Failure for joint plane trending N015°/75°

- i) The joint plane N015°/75° passes through the critical zone for Topple Failure (shaded triangle in Fig 9a). Hence, toppling is possible here.

The input parameters for analysis of "Sum of Moments" in case of Toppling Failure is shown in Fig 9b, where the value of "Sum of Moments" comes out to be 107.2 kN/m, indicating unsafe slope conditions.

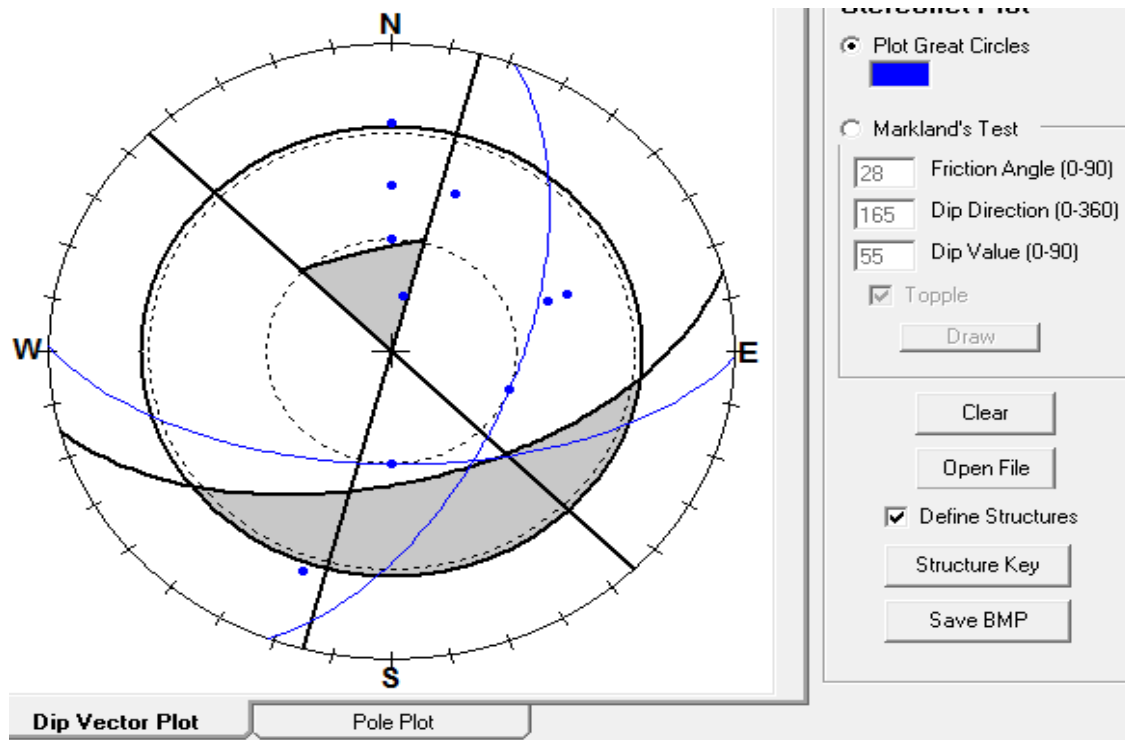
Figure.10a Analysis for Wedge Failure

- ii) On the other hand, Wedge Failure is indicated by the intersection of joint planes N180°/60° and N110°/60° that lie very close to the critical zone (Fig 10a). The likelihood of Wedge Failure is analyzed for the Factor of Safety through the software. The input parameters for determination of Factor of Safety are shown in Fig 10b.

The analysis gives the value of 1.78 for the Factor of Safety, which indicates safe conditions as far as Wedge Failure is concerned.

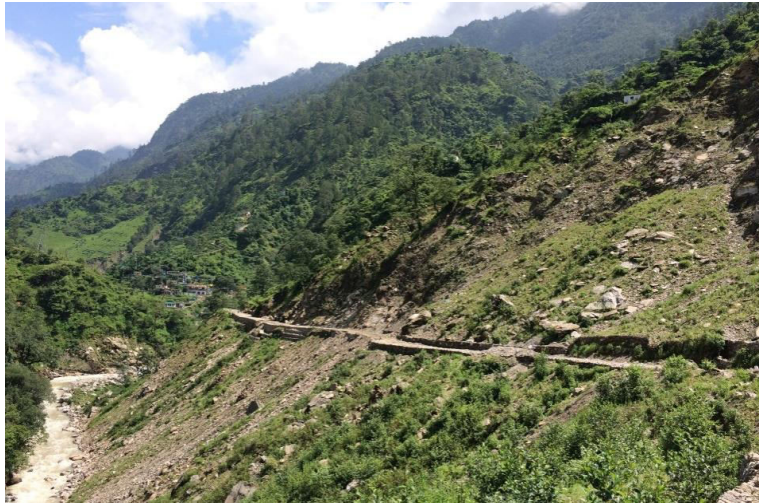
Further investigations show that the groundwater is playing a major role in the activation of slide. The major patch, which is affected by the slide, has crown elevation

of 70m and mainly contains debris slide. The slide that pass through the road is characterized by dormant as well as active debris slide. The slope of the slide varies from 45° to 60°. The rocks are highly jointed, fractured and even show shearing effect at few places.

**Figure.11** A view of the km 8 Slide Zone from crown to toe

It may include drainage control of rain water; construction of gabion walls / bench walls / berms / retaining walls; setting up ring net; planting vetiver grass / geo-fabric; etc. at suitable places.

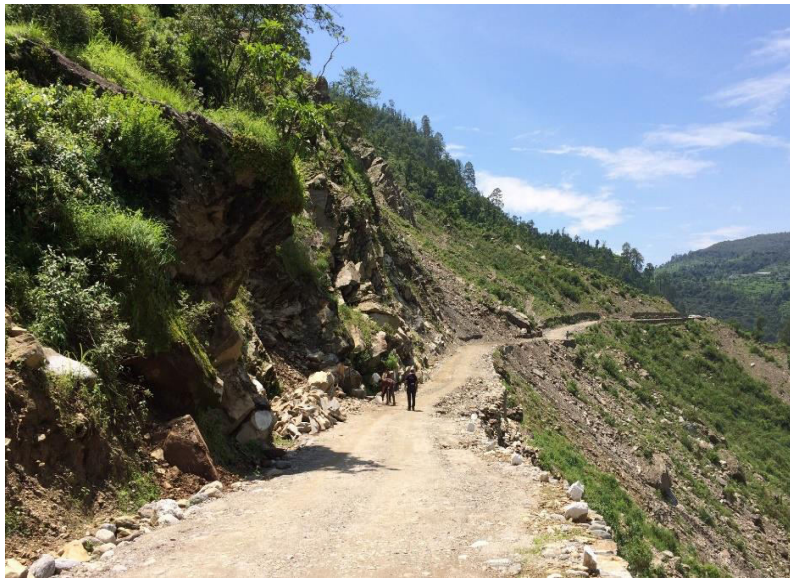
**Figure.12** Another end of the slide zone with steep slope. Rocks are exposed along the road, followed by debris.
