## Geological Assessment of A Slide Zone on SH-36, Near Kalimath in Rudraprayag District, Uttarakhand, India

A landslide zone stretching nearly 400 m along the SH-36 with the length of 115 m is located nearly 8 km from Guptkashi on way to Kalimath Village in Rudraprayag District, Uttarakhand. The rocks in the slide zone vicinity belongs to Kalimath Formation of Jutogh Group that falls under the Higher Himalaya. The rocks in the slide area are characterized by intercalated sequence of quartzite, schist and gneiss with thin bands of amphibolite. Regional strike of these rocks is E-W dipping due north. The rocks are fragile due to excess seepage of water at places. There are three sets of prominent joints with some variation and random joints. The kinematic analysis indicates possibilities of toppling of the rock blocks particularly with intersection of the joint planes N010°/75° and N110°/60°, where slope is trending N250°/65°. Similarly, toppling has also been indicated by the joint plane N015°/75°, where slope is trending N165°/55°. The 'Sum of Moments' comes out to be 113.57 kN/m, and 107.2 kN/m, respectively, for these two slope conditions, which indicates unsafe slope condition

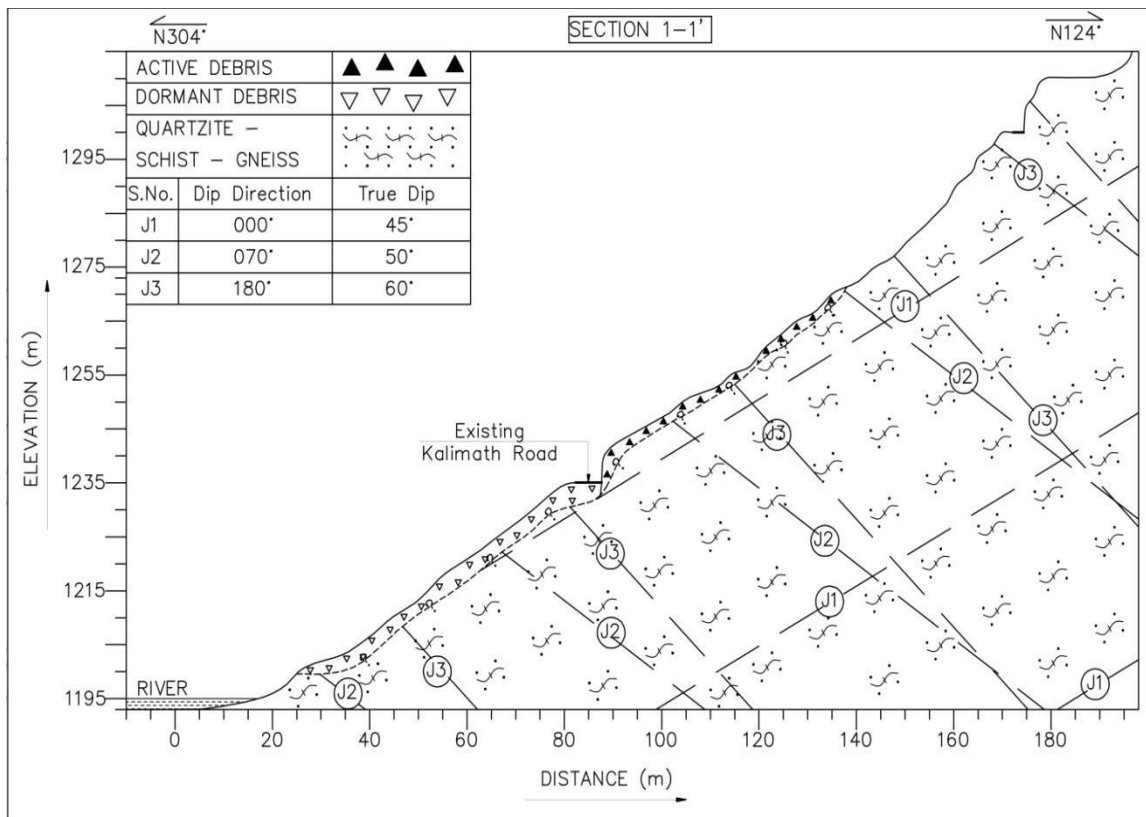
Figure.3 Geological Cross-section along 2-2'

Further, four geological cross-sections have been prepared to understand the lithological and slope relation along with the joint pattern. The section lines have been shown in the Geological Map (Fig 1) and the cross sections have been shown in Figures 2 to 5.
